NATIONAL TRANSPORTATION SAFETY BOARD

SURVIVAL FACTORS GROUP CHAIRMAN'S FACTUAL REPORT

November 22, 2013

Operator : Asiana Airlines
Airplane : Boeing 777-200ER [HL7742]
Location : San Francisco, CA
Date : July 6, 2013
Time : 1128 Pacific daylight time (PDT)¹
NTSB # : DCA13MA120

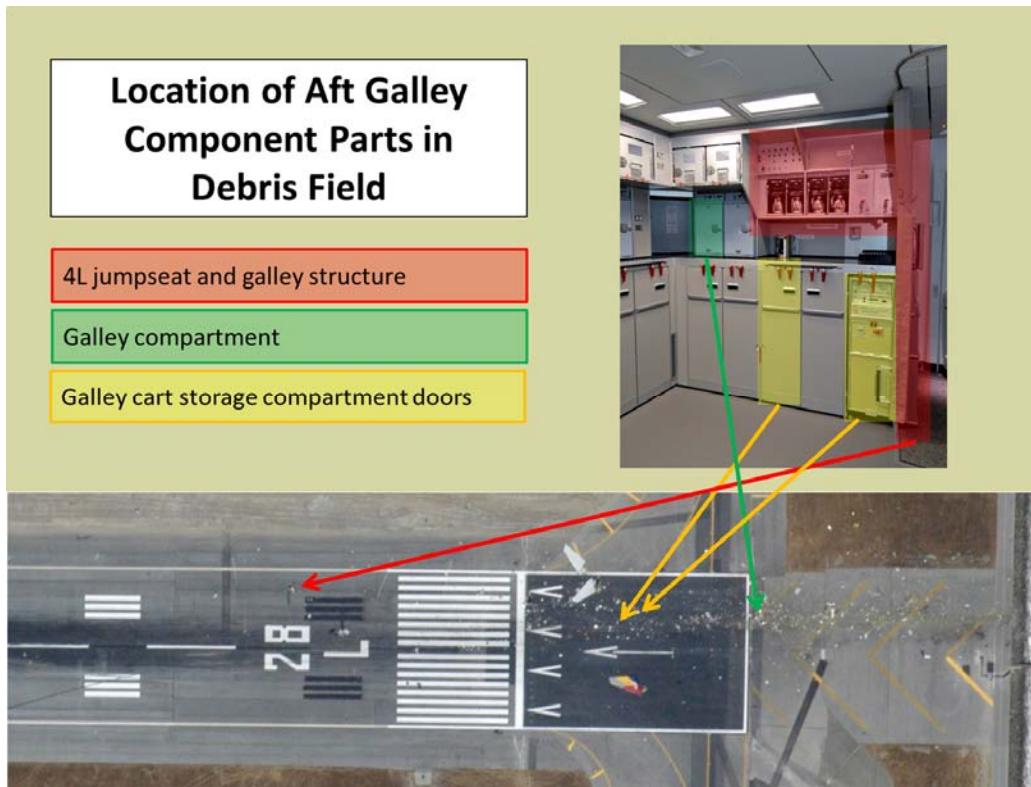
Figure 3. Location of 4L jumpseat and aft galley components in the debris field.

The 4L forward-facing jumpseat was ejected from the airplane and was found to the right of runway 28L centerline, approximately 500 feet from the runway threshold. It remained attached to a section of aft galley and the galley tie rods were sheared at a 45 degree angle. The seat was relatively undamaged and the seatpan retracted normally.

The aft galley was destroyed in the airplane's initial impact and slide down runway 28L. The Survival Factors Group documented the location of significant items of mass with the assistance of the FBI's total station surveying equipment. The documentation focused on items with a Boeing part number that could be identified as originating from a particular location on the airplane. The first identifiable item from the airplane cabin was a small section of galley floor that was found just beyond the seawall. Locations of selected items can be seen in the figures below:

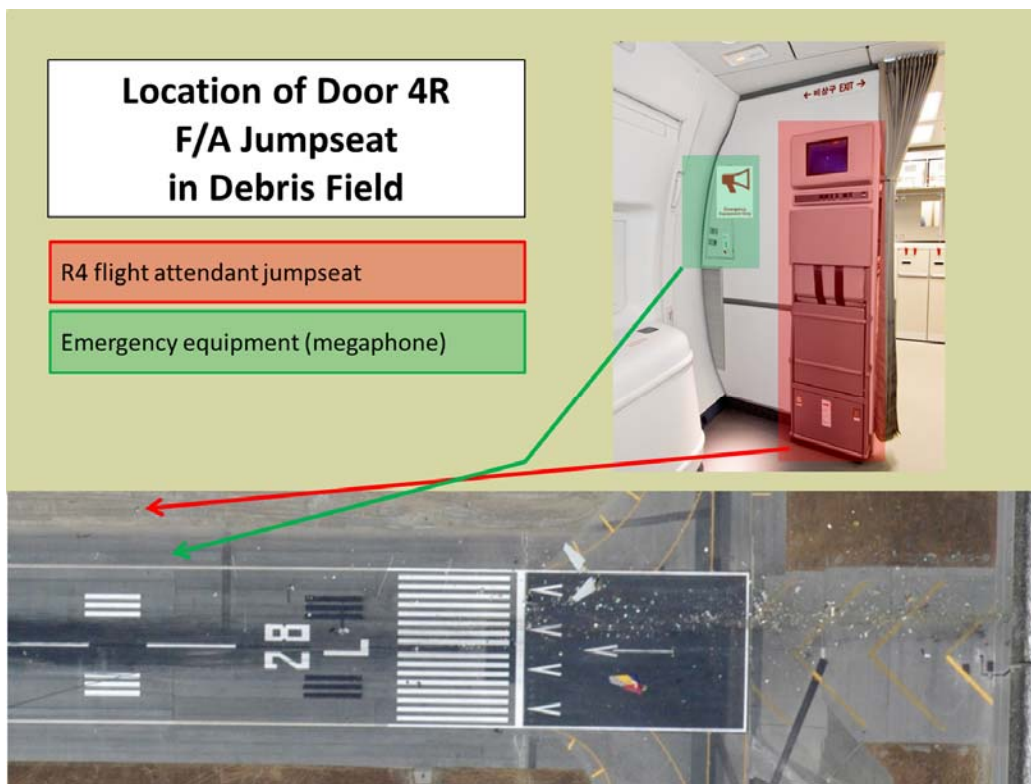
Figure 4. Location of 4R F/A jumpseat in debris field.

The 4R forward-facing jumpseat was ejected from the airplane was found to the right of runway 28L centerline, approximately 550 feet from the runway threshold. It remained attached to a section of aft galley and the galley tie rods were broken at a 45 degree angle. The galley structure was also fractured at the level of the head rest. The seatpan was deformed and there was abrasion damage on outboard corner of the seatpan. The four-point restraint was unlatched, undamaged, and functioned normally. The following information was obtained from the restraint:
